REPORT

WATER SUPPLY COMMISSION

PENNSYLVANIA

1912

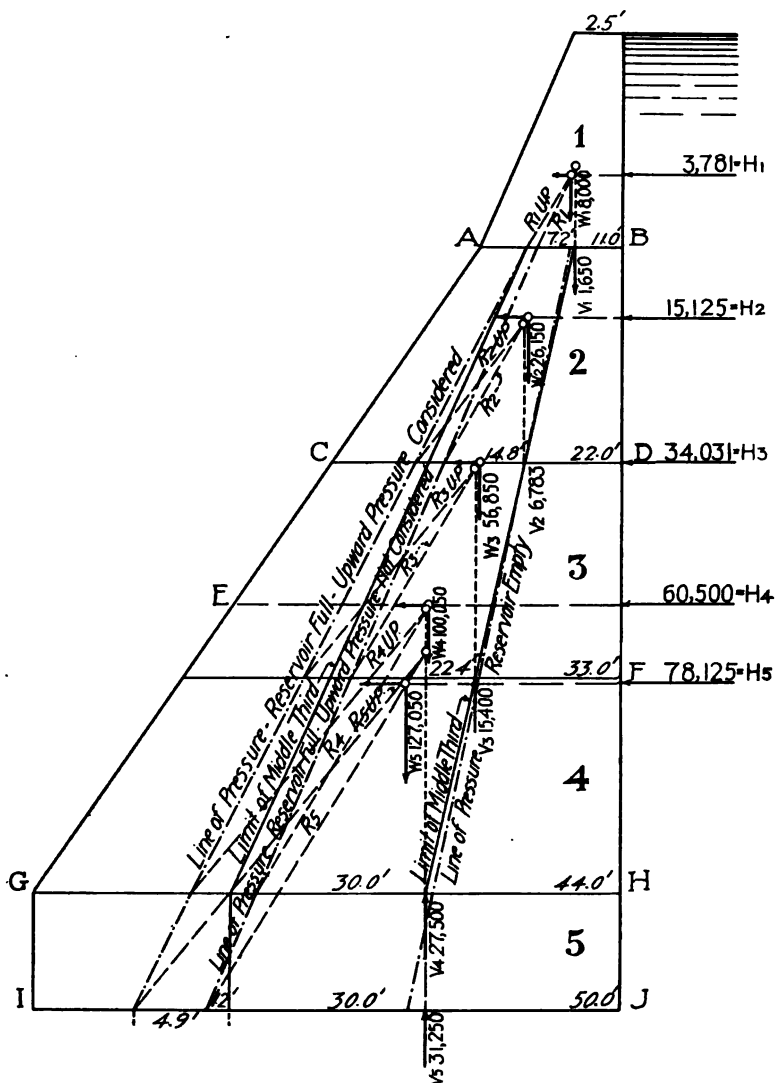
Calculations were made of the stability of the dam, using 150 pounds per cubic foot as the weight of the masonry, which is in approximate accordance with the results of the tests quoted above. Joints were assumed to be 11, 22, 33 and 44 feet below the top of the dam, and at the base, as shown on Figure 5.

In Case No. 1 the reservoir was assumed to be empty. The line of pressure is found to be slightly within the middle third at the first joint A-B, 11 feet from the top of the dam; below this point it lies just outside of the middle third until the base is reached, where it is slightly within the middle third. The dam may be assumed to be stable under this condition, as the pressures are not large.

In Case No. 2, the reservoir was taken as full, but upward pressure was not assumed as acting upon the dam. The line of pressure is found to lie within the middle third at all joints until the base is reached, where it is 1.2 feet outside of the one-third point. The line of pressure should have been kept within the middle third of the dam at every joint.

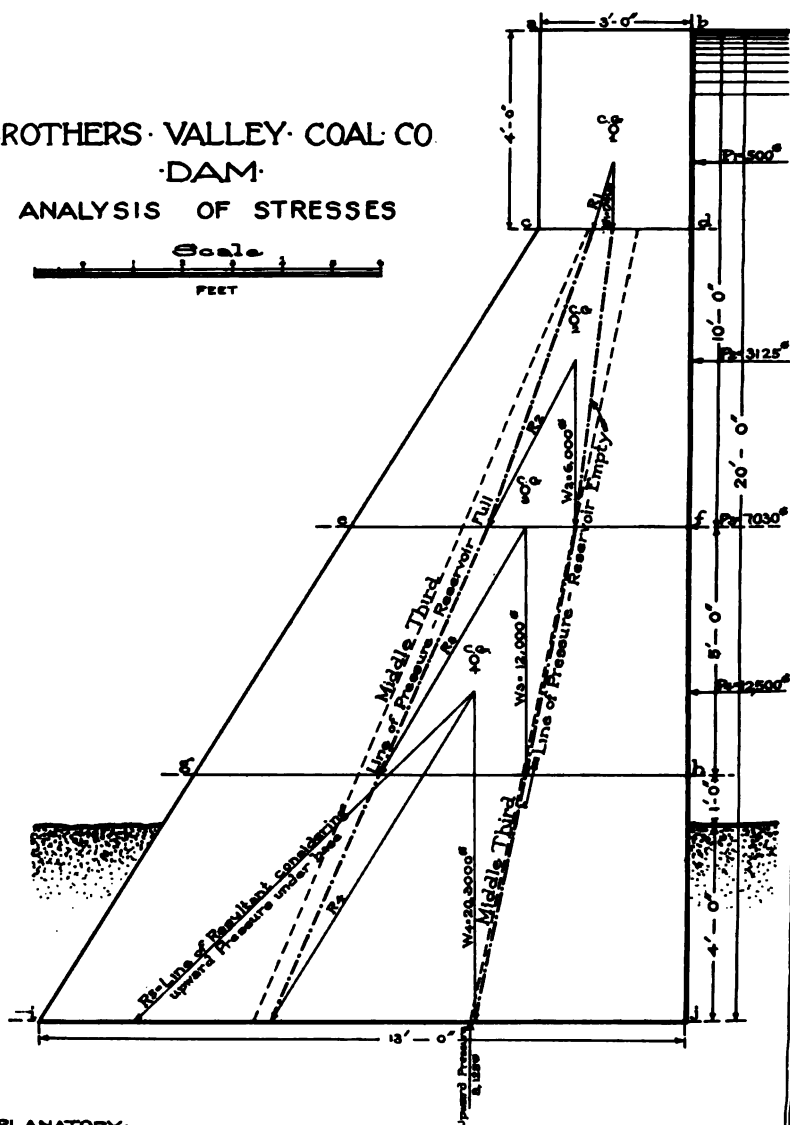
MACDONALDTON DAM.

The dam, which was designed by engineers of the coal company, and built with company labor under the supervision of the designers, was constructed of concrete, with a vertical upstream face. The length on the crest was 419 feet, and maximum height above the ground surface 16 feet, while the foundation extended below the surface a distance of four feet. The top width of 3 feet remained the same to a point 4 feet below the crest, from which point the downstream face was battered, so that the width of the base was 13 feet.

The dam rested for two-thirds of its length upon a foundation of clay, and for the remaining third upon shale; and no precautions were taken to prevent the percolation of water beneath it, or to prevent sliding. The excess excavation in the trench was generally back-filled with the nearest material at hand,—clay, soil, or swamp muck,—and the puddle effect to be desired was not secured. Near the center of the dam was a spillway, 6 feet wide and 1 foot deep, while through the dam was a 16-inch waste pipe, and an 8-inch supply pipe, with valves near the downstream toe.

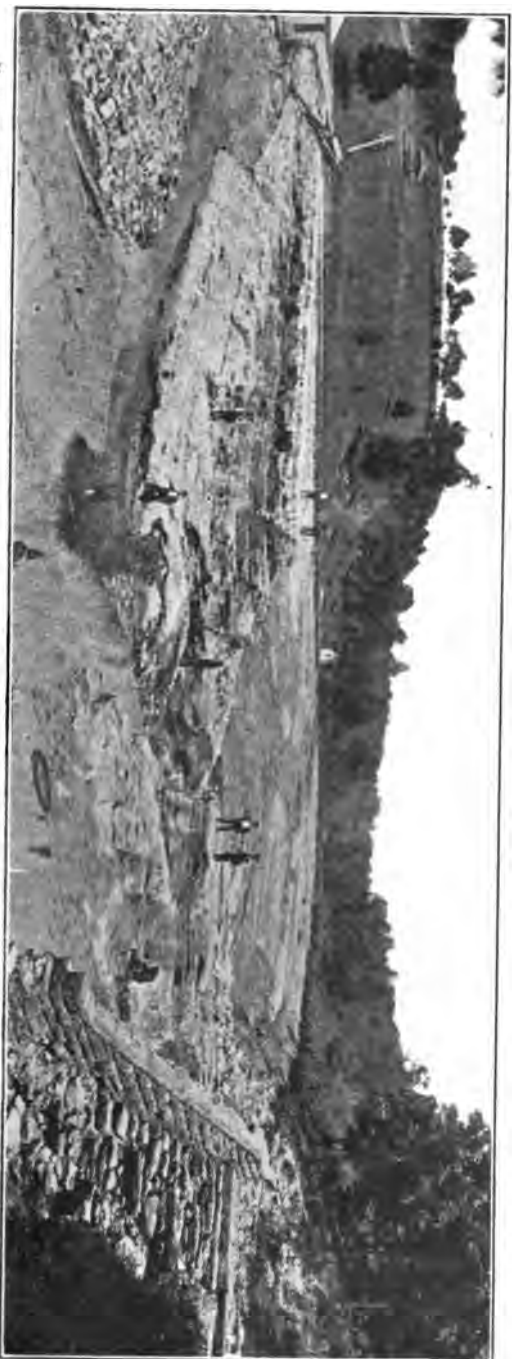
OAKFORD PARK DAM.

The failure of the Oakford Park Dam, on a small stream in Western Pennsylvania, which resulted in the loss of twenty-three lives, shows that a great catastrophe may be caused by the failure of a comparatively small dam, and accentuates the importance of supervision over such structures.

The dam was about 25 feet in maximum height, constructed of puddled earth, with a spillway at one end. It was 321 feet long and $14\frac{1}{2}$ feet wide on the crest. Both slopes were 1 on 2, and were dry paved with flat stones, averaging 4 inches in thickness, 12 to

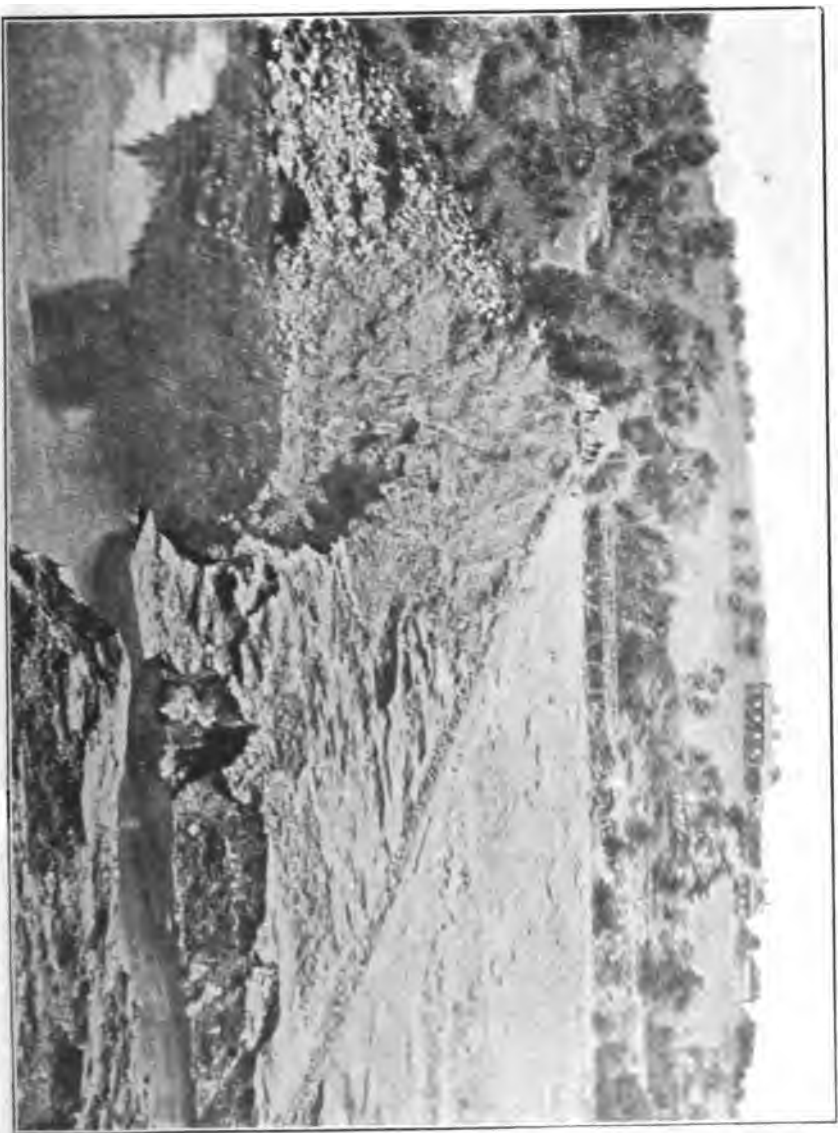
General View of South Fork Dam after Failure.

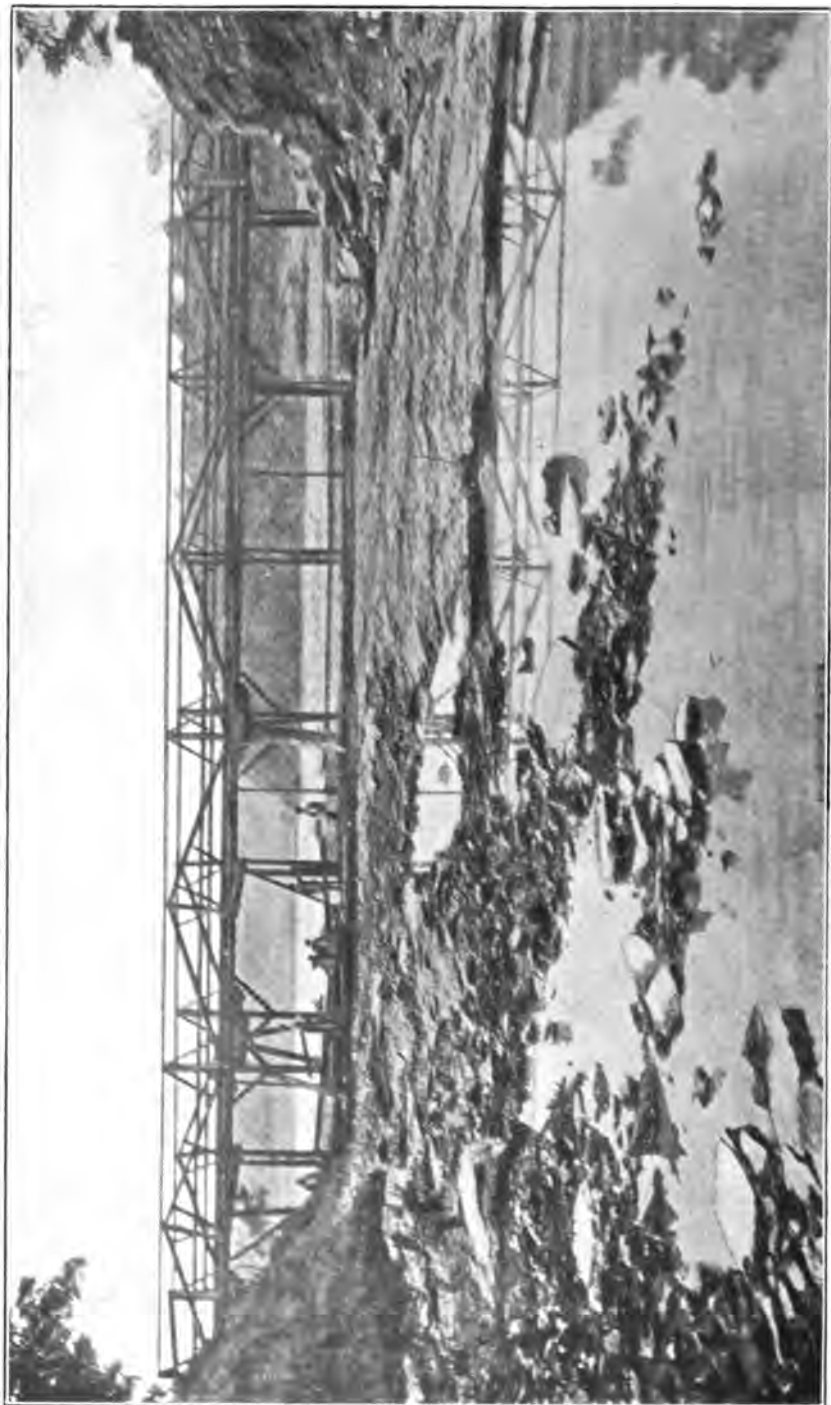
From Trans. Am. S. C. E. The Break in the South Fork Dam, Looking West.

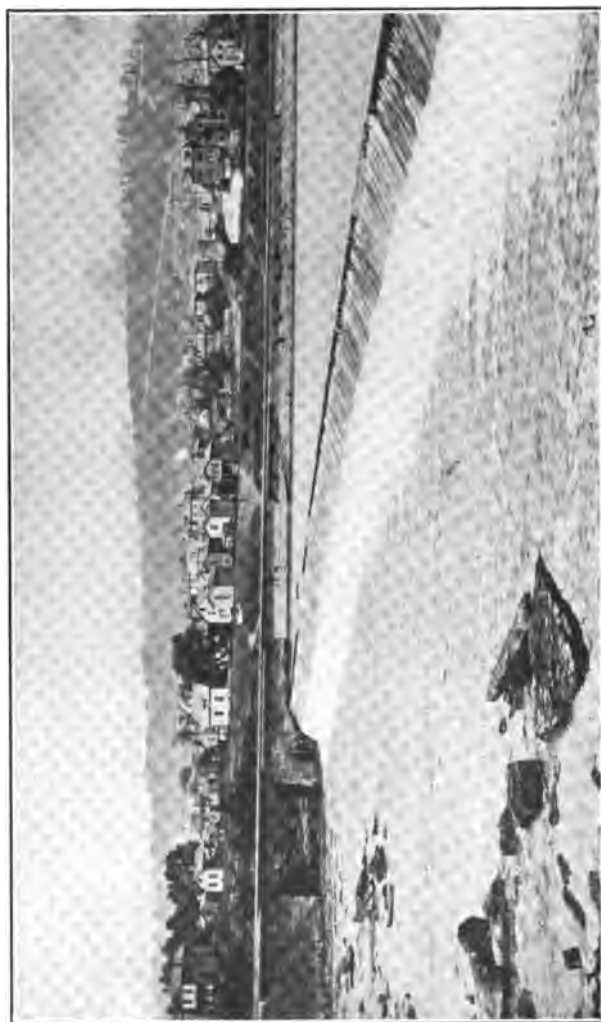
Shenango River at Sharon.

Sharon, population 15,270, and Farrell, formerly South Sharon, population 10,190, form a great industrial center of this valley, in which steel and iron works of various kinds line the banks for miles, withdrawing many million gallons of water from the river daily and discharging back the heated water and manufacturing wastes. The two boroughs obtain a water supply from the stream and their sewage, garbage and other city wastes are deposited therein. Much of the river, through these boroughs, is walled in on both sides, bridges cross the stream and bars and waste deposits obstruct the channel. At Farrell Big Yankee run, a large tributary, enters from Ohio and at this point the water of the stream, in summer, reaches a high temperature, owing to repeated use, and it is discolored by industrial and city wastes.
